MOORES LAKE DAM  
BOONE COUNTY, MISSOURI  
MO. 11173

**PHASE I INSPECTION REPORT**

**NATIONAL DAM SAFETY PROGRAM.**

DECEMBER 1980

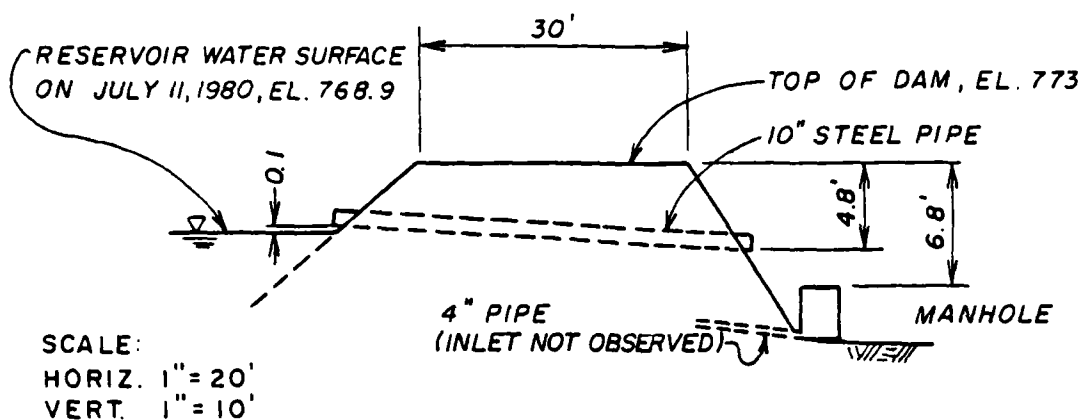
SECTION THROUGH EMBANKMENT  
AT LEFT ABUTMENT

The 4-inch pipe, according to Mr. Anderson, is located at the left abutment of the dam. The pipe was not located on the day of the inspection; however, the outlet structure for the pipe, according to Mr. Anderson, was a manhole on the downstream slope which was observed (see photo 8 and Plate 3). The outlet structure consists of a 2.25-foot wide diameter manhole with the bottom of the manhole located about 7 feet below the top of the manhole, which is also assumed to be the location of the outlet of the 4-inch diameter pipe (see Photo 10). The manhole is of brick and concrete mortar construction. The crest elevation of the pipe is unknown. According to Mr. Anderson, this pipe is controlled by a valve. Therefore, this pipe is considered to be a low level outlet type structure. Nevertheless, the valve was not located on the day of the inspection.

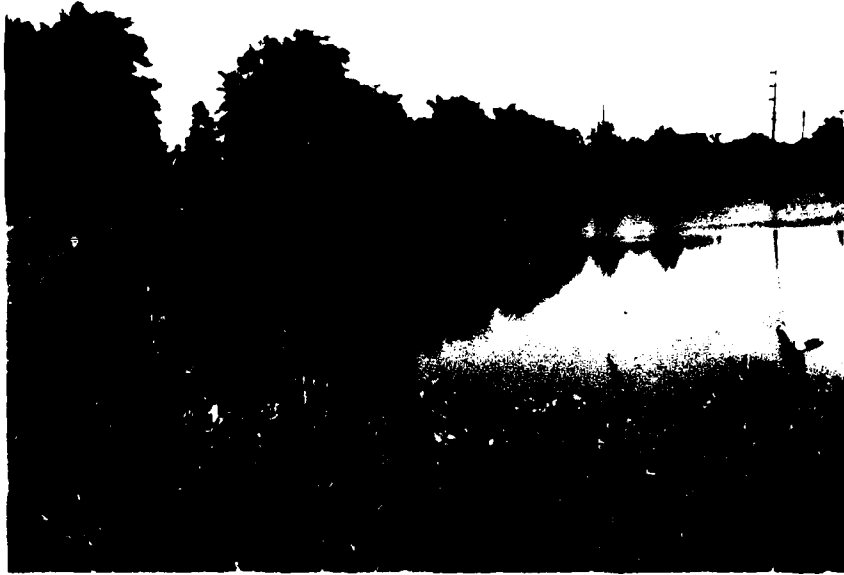
- Photo 1 - View of the upstream slope from the left abutment showing the dense vegetation.
- Photo 2 - View of a portion of the top of dam from the left abutment. Note the disturbed area of soil in the foreground due to the recently constructed 10-inch spillway pipe.
